KOMMOS ARCHAEOLOGICAL PARK

Ενημερωμένη Μελέτη Ανάπτυξης και Συντήρησης
Conservation and Development Plan Update

14 Φεβρουαρίου 2015 / 14 February 2015

2015 UPDATED CONSERVATION AND DEVELOPMENT PLAN
for the Kommos Archaeological Site – Pitsidia Crete Greece
14 February 2015 by James Stratis for Kommos Conservancy

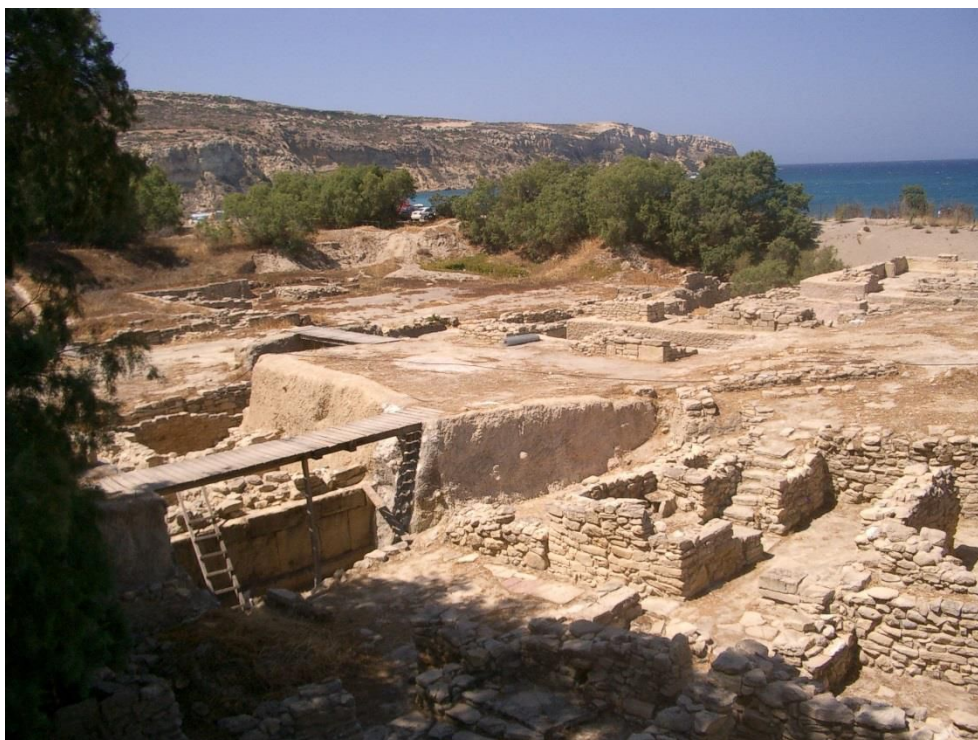
Photo 1: view south across west side of Southern Area

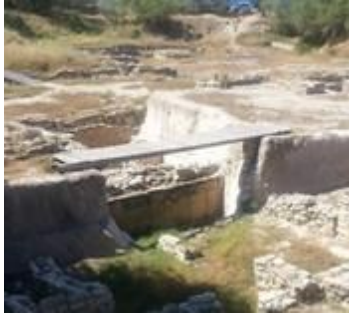
Photo #02a

Sub surface collection
well and pump location
below bridged walkway
see page 19 for increased
image size and additional
close up of location.

Following several years of observation it has been confirmed by the author and the local site watchman Sifis Fasoulakis that the drainage at the exposed eastern section of the Minoan road does adequately drain, eliminating any need for a sump pump or roof covering for area 1a indicated in the 2005 updated conservation plan.

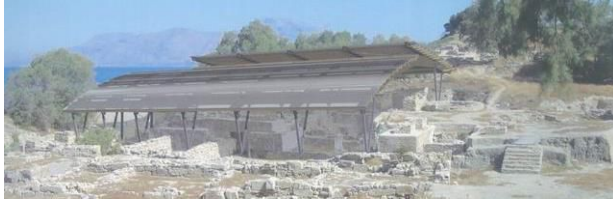
Photo #03: Sonia Mavrommati 2007 Roof shelter rendering over Greek temples see page 21 for increased image size

In June 2006 private funds from North America were utilized to hire experienced and highly esteemed Greek conservation architects Clair Palyvou and Sonia Mavrommati to review conditions on site and create design development level planning documentation for roof shelter structures over the Greek temple complex and the kiln structure located against the south stoa wall opposite the Minoan era central courtyard, some forty two meters to the south of the temple complex (see fig 1 of plans below and attached fold out). After the architects reviewed the engineering criteria associated with height, span, environmental conditions and park interpretive viewing locations, the simple lean metal pole columns and steel web trusses installed in other archaeological parks within Crete and referenced as recommendations in the previous reports, were determined to be unacceptable given the safety standards that have evolved and which would be required since the last quarter of the twentieth century. The new structural form would be arched similar to those previously studied at Malia but would be metal, utilizing the most up to date coatings to account for the salt air environment and extended lifecycle and maintenance performance criteria. Gutters, downspouts, splash blocks or other roof surface water disbursement management, will be detailed and located in the final construction documents phase.

These plans were submitted to the Central Archaeological Council (K.A.S.) and conditionally approved on 31 July 2008. They form a basis for a continuation of the next planning step, involving foundation placement study as part of the construction documents phase of planning. These steps have been reviewed with

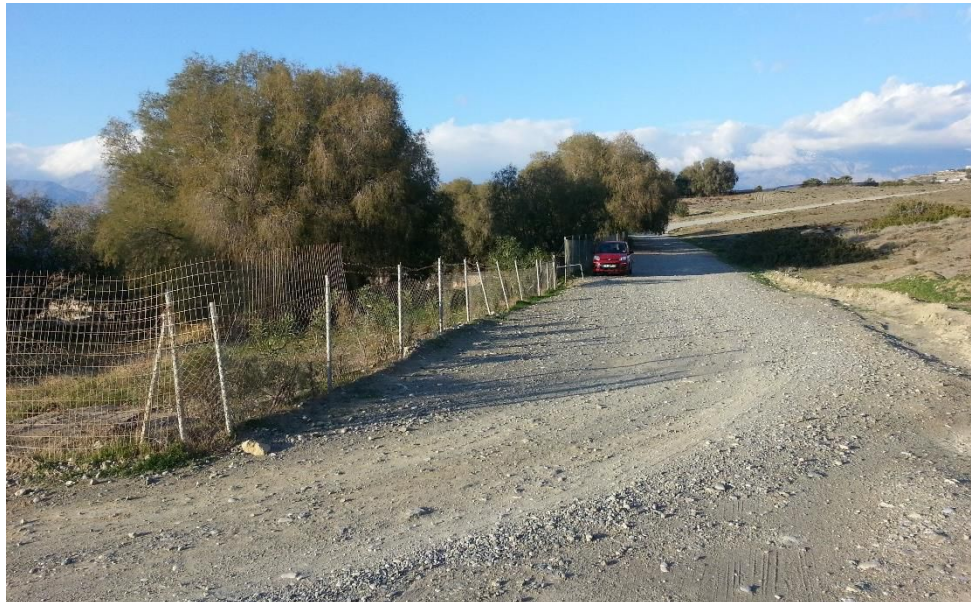
Photo #4: View north, up east perimeter fence and raised beach access road east of site.

The schematic plan addressed the surface drainage across the beach access road directly to the east of the site's fenced boundary. Through the cooperation and direct management of the local municipality's villages of Pitsidia and Matala, personnel, material and equipment were utilized to raise the road bed, effectively eliminating the immediate need to install a traditional curb and gutter or lined swale as represented in the previous plans. The road is compacted soil and gravel and will have a shorter life cycle than a hard surface of stone paving or asphalt. A concrete swale or curb and gutter on the upslope side of the eastern road is still the preferred long term solution to intercept and redirect, the sloped eastern surface drainage.

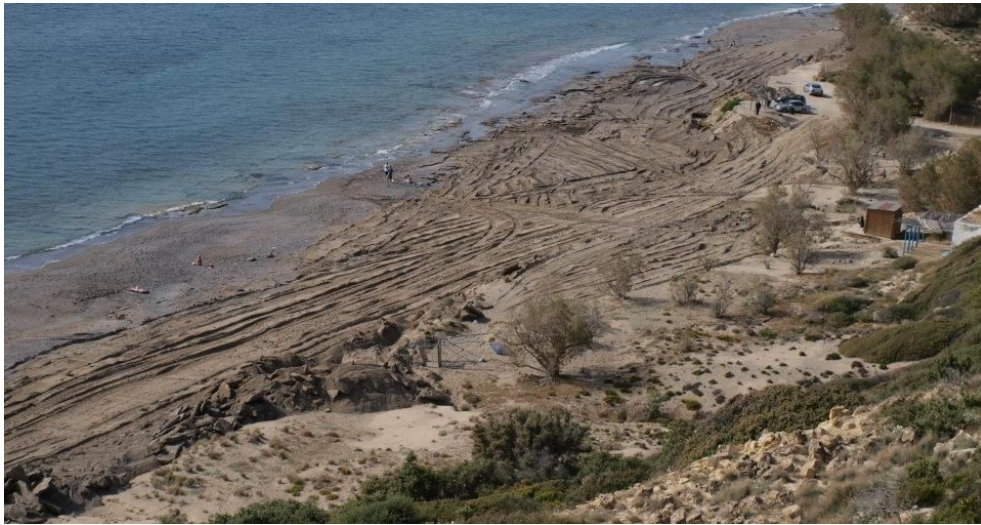
Photo #5: disturbed beach area with piled stone slabs at eastern edge of beach just south of Kommos site

Managing the erosion and alluvium deposition was only determined necessary and addressed in past studies within the Southern Area. Since the original treatment recommendations, other well intended but illegal efforts focused on the seaward western side of the site have occurred. The placement of large stone slabs to enhance the stability of the toe of the western slopes at the beach could be a beneficial treatment, however, the beach is a protected turtle nesting area and proper planning and permitting are required by law. The extent to which the sea is rising should be documented and mitigation treatments should be considered and incorporated into a future long range site maintenance and archaeological park management plans.

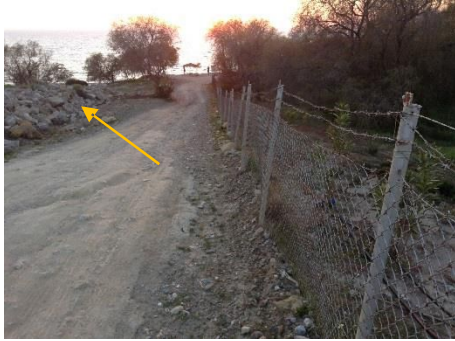
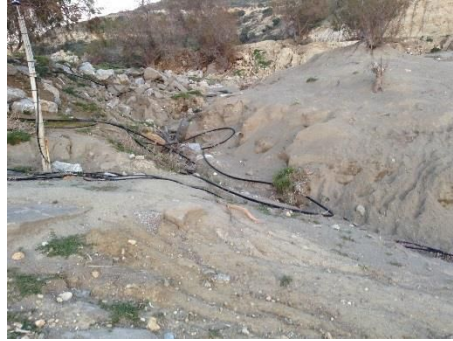
Photo #6: south fence & stone pile across Photo #7: south of beach access road at beach the outlet protection location

At the southern fence line to the Kommos site the beach access road turns to the west parallel to the fence. It is due south of this road where large stones have been piled up, but at the point where the parking area meets the beach, seen in photo 5 above, the concrete lined swale 1c above had been proposed in our earlier schematic master plan to drain onto the beach through an engineered reinforced (protection) outlet. The design intent was to intercept all surface drainage east of the Kommos site and redirect it to this managed outflow. The road bed raised by the municipality and the piled up stones at the northern edge of the private parking area south of the fenced archaeological site, appear to adequately address the overflow into the site as documented in the original conservation plan. The outlet at the beach is unengineered and unmanaged and should still have outlet protection.

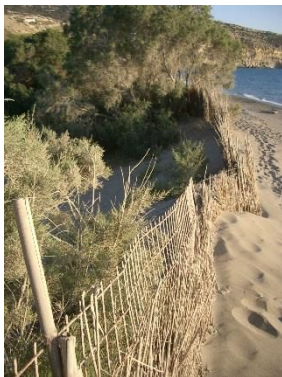
Photo #8: west fence wind caused sand build-up

The area directly against the western fence had been cleared during the excavation, sand had been piled against the western perimeter in the Southern Area, effectively forming a barrier between the beach and the re-exposed ruins within this area of the site. It was observed that the winds had lifted sand above this physical sand berm and then having reduced energy dropped substantial sand at the foot of the eastern edge of the berm barrier, effectively reburying a portion of the Minoan era monumental building's floors and the Minoan Road that served the in-land harbor transfer of goods.

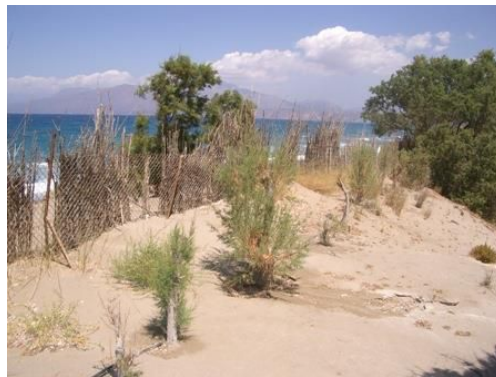
Photo #9: west fence tamarisk sprig & drip line (no longer operational)

A water line was brought down to the site by the local municipality but has not been maintained and fledgling planted tamarisk starter plants have mostly died. There has not been a budget allocation in recent years for the irrigation system maintenance and operation, the infrastructure is mostly in ruin. This natural wind barrier should be reestablished and maintained. The tamarisk tree barrier line will probably also necessitate low skill level maintenance of the re-deposited sand against the western edge of the site's fence line. The 1998 Plan and Master Plan graphic suggested a reinforced synthetic start-up screen (IIb. Pgs 9, 31 and figure 4) Placing the tamarisk line to the west of the fence will provide a reduced risk of public illegal breaching of the fence and reduced maintenance directly against the fence. Constructing a temporary start-up screen on the beach property will require coordination and permissions not accomplished to date. Perhaps the tamarisk line at the western fence will prove sufficient, negating the need for another approval process.

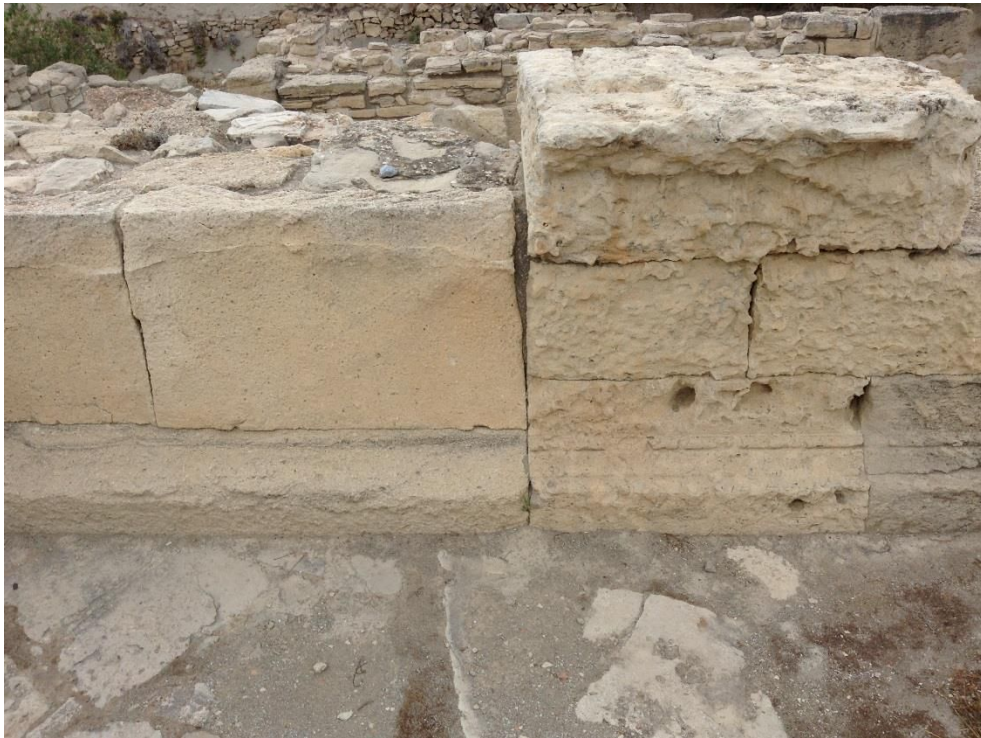
The loss of surface fabric in the south is significant since the original 1998 assessment and plan. To what extent the cause is by water or wind is unknown and under analyzed. Quantified measurements should be undertaken by photogrammetry or by laser scanning, prior to protective roof construction.

Photo #10: Greek temple stone deterioration

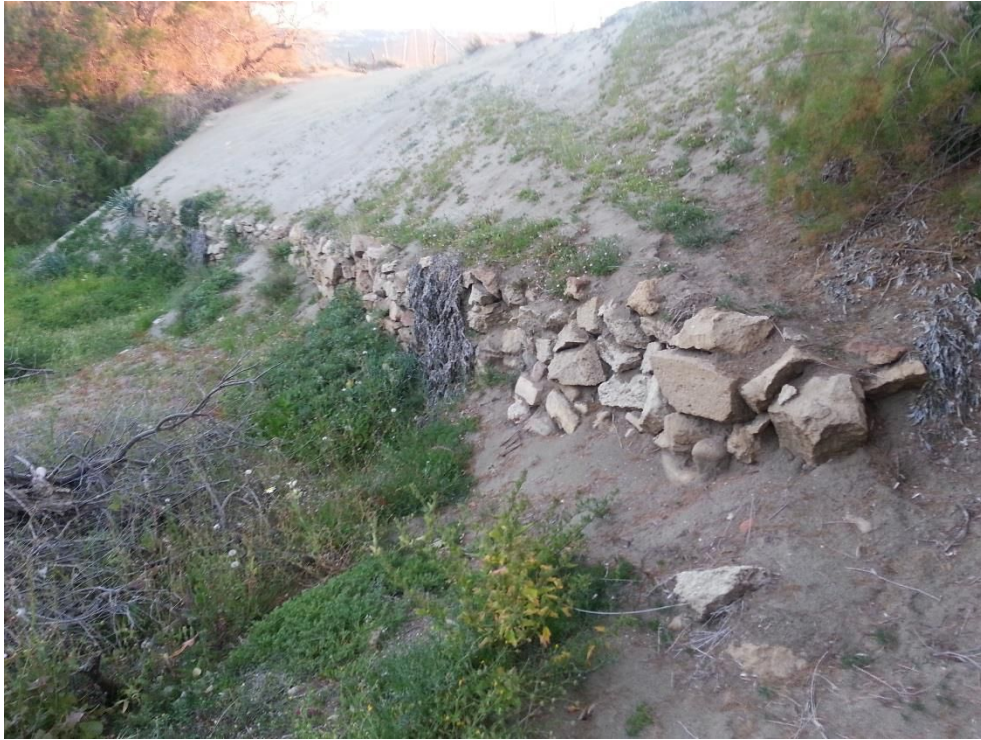
north western portion of the Southern Area are being reburied. This is not a conservation problem but a future issue for interpretation once the site is made into a park and opened to the public. In fact the effectiveness of the palm frond wind barrier increased the possibility of a fence breach by the beach visitors.

Photo #11: north western portion of Southern Area – sand build up within the site at western fence line

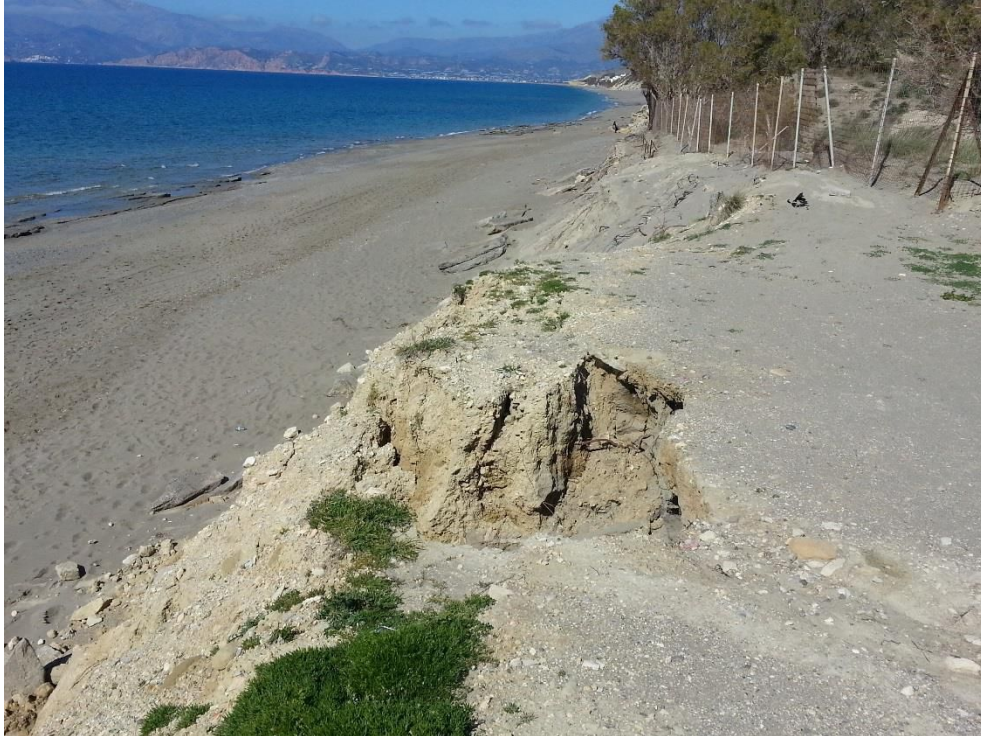
There is a changed landscape at the western edge of the Southern Area. An embankment of sand has created an unstable platform, and this is a good modification concerning site stability, but the embankment has been severely deteriorated over 2014 from rain surface erosion.

Photo #12: western fence and erosion see page 19 for additional images of this area

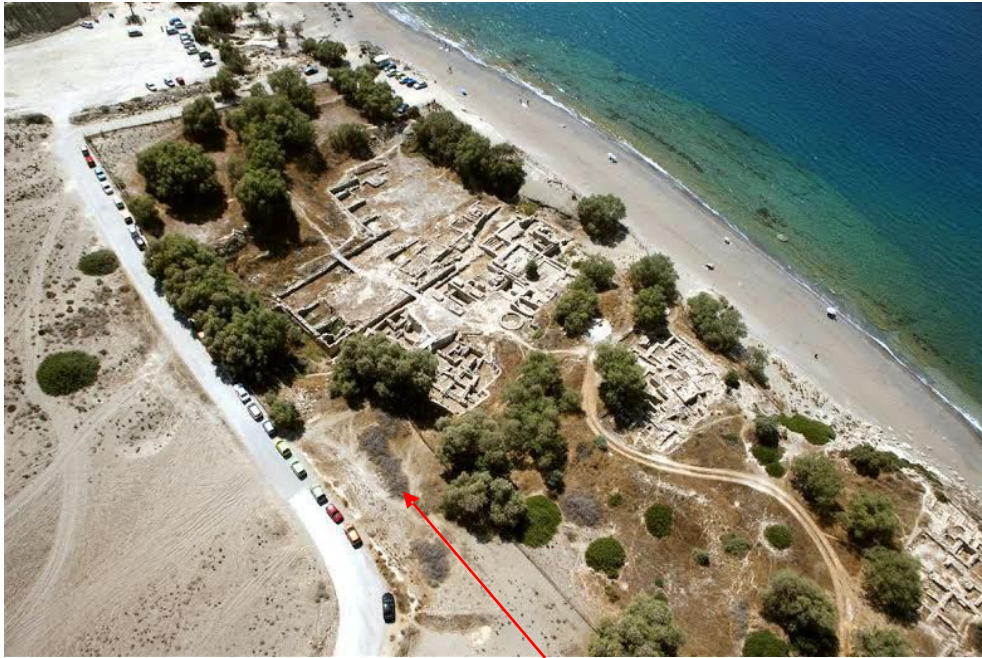
Photo #14: arrow spans across proposed parking area from 1998 Conservation and Development plan. Photo provided by the Phaistos Municipal mayoral administration of Maria Petrakogiorgi Anyfantaki 2013.

Consistent with the previously submitted 1998 and 2005 conceptual master plan, provision for buses, campers, 84-92 cars and motorcycles has been schematically located outside the upper north-eastern fence line on private property, in an area of approximately 4200 square meters. Advantageous provisions for bicycles and perhaps other compact non-motorized vehicles can be located with installed racks closer to the entry building complex. All vehicular parking should be coordinated with the municipality of Pitsidia, the entity which manages the Kommos beach.

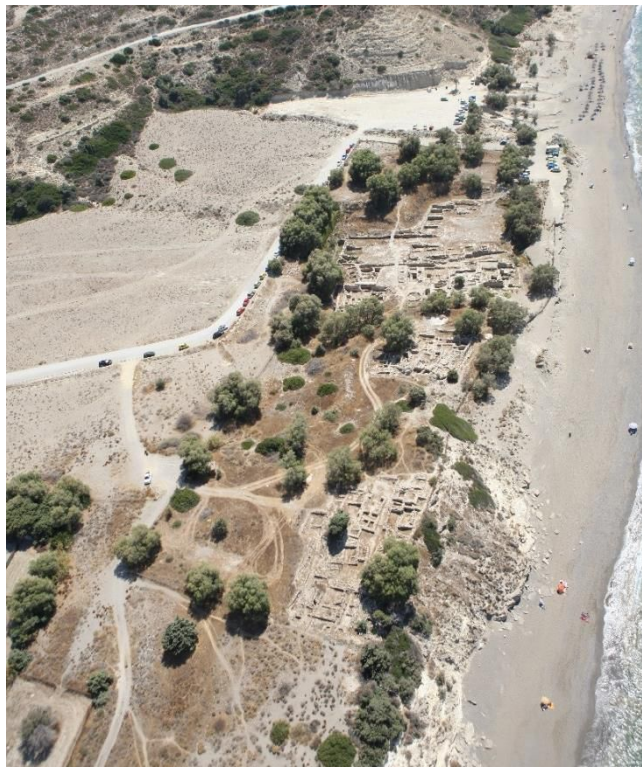
Photo #15: Three Kommos excavated areas viewed from the north looking south, provided by the Phaistos Municipal mayoral administration of Maria Petrakogiorgi Anyfantaki 2013.

Some especially important areas remain to be excavated: Middle Minoan houses on the hillside are particularly well preserved, and three of the great galleries for ships await future excavation techniques for best results. Park development planning should include consideration of equipment access to provide for future excavation. This may be facilitated by the north eastern and southern gateways as indicated in the conceptual master plan and which are currently extant.

Eventual park operational planning should include identification of the prehistoric unexcavated features boundaries through remote sensing techniques and consideration for monitoring and protection of unexcavated areas both within and outside the present fenced perimeter.

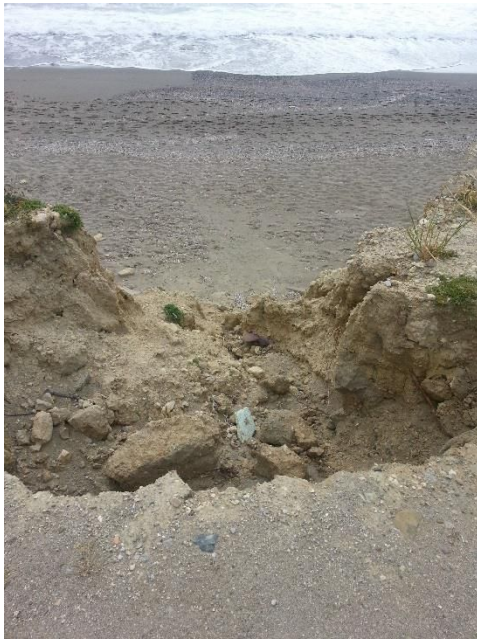
Photo #17: erosion at Built up S.W. of fence

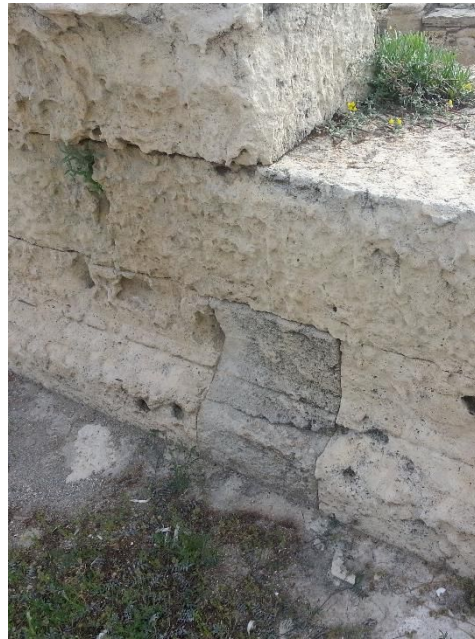
Photo #18: Erosion of Greek Temple stone

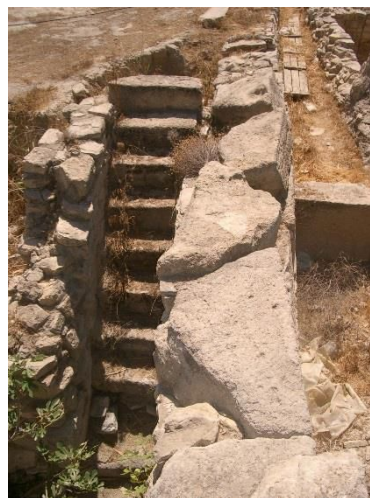
Photo #20: Stairs and wall cap
N.E. corner Bldg. P (ca. 1400 BC)

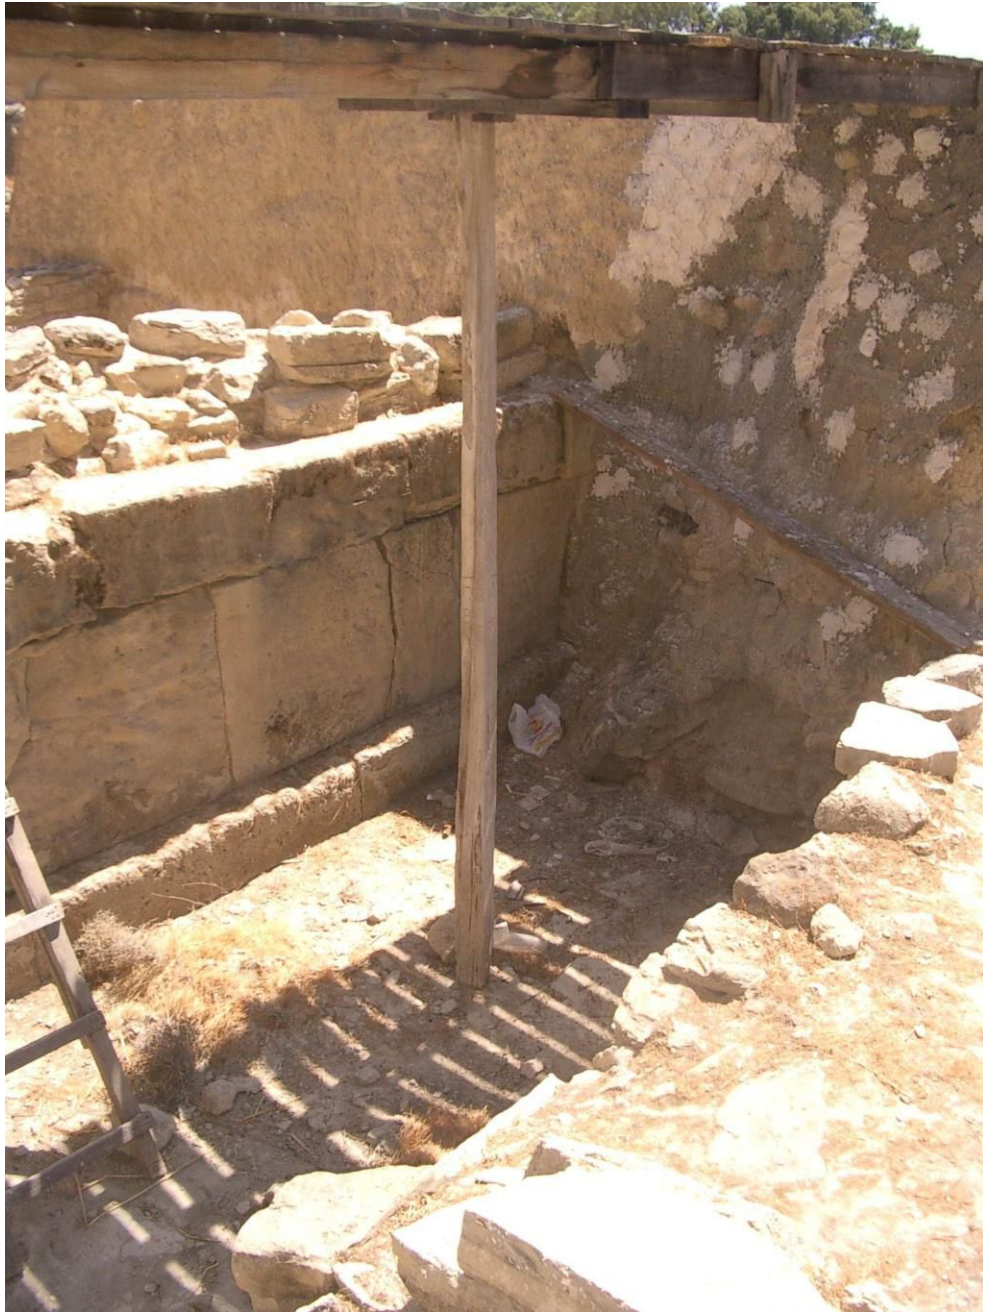
Photo #2b: excavated area indicating potential ponding area, determined to drain adequately without intervention. See photos 1 & 2a and Section 1a

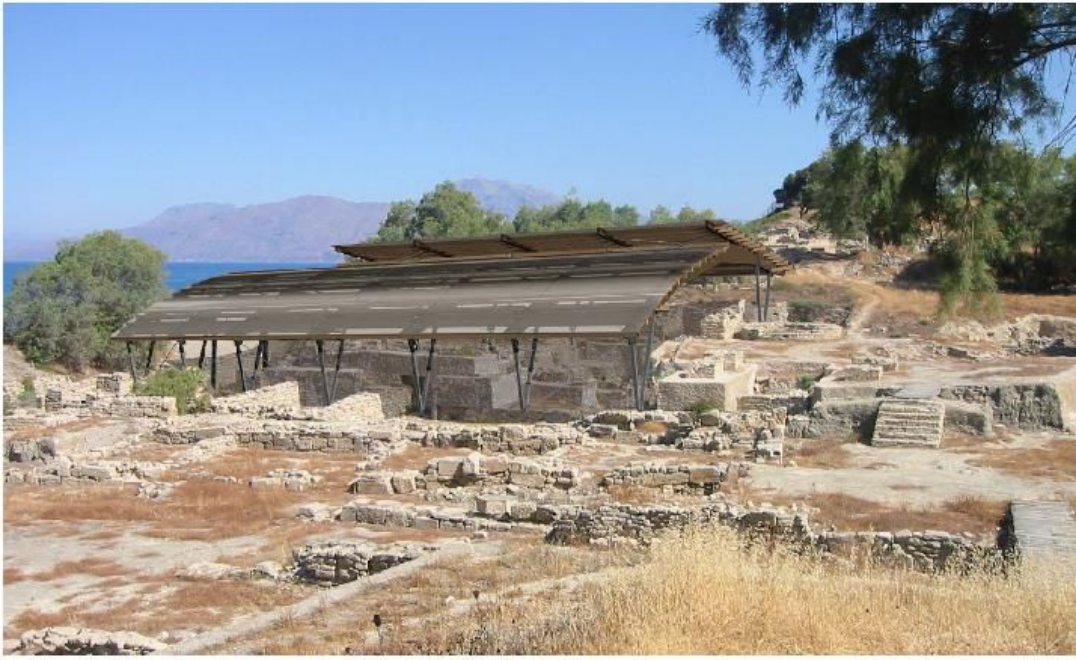
Photo #03 Roof shelter view north west from viewing area above shipsheds / Southern Area, superimposed shelter image by S. Mavrommati 2006

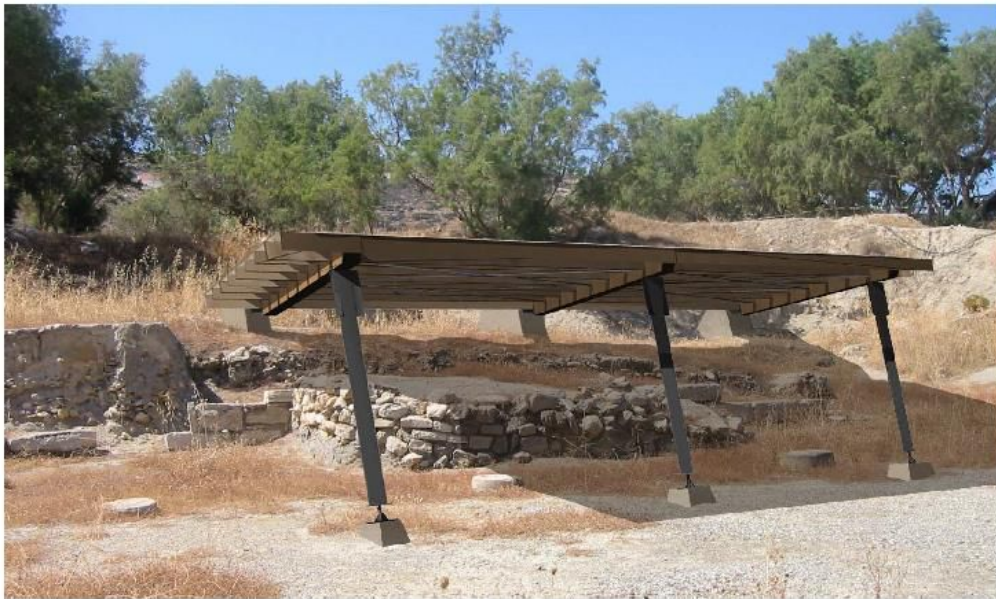
Photo #21: Superimposed roof shelter over kiln in south stoa - 2006 S. Mavrommati
