## *Report on Storm Damage at Kommos to the Heraklion Ephoreia*

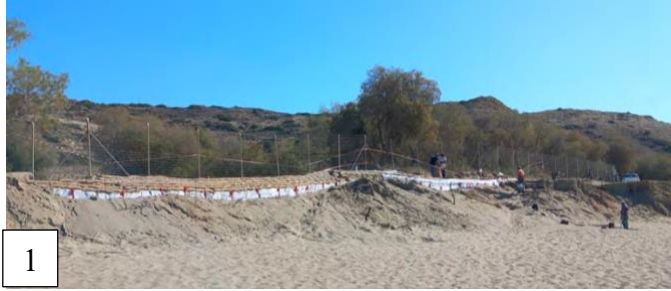
1

On Friday, February 20, 2026, I received notice from the foreman of my conservation team, Giorgos Misemikes, that the archaeological site at Kommos had been severely damaged by a powerful storm. Photographs of the damage show that strong waves, wind, and torrential downfalls of water swept away the beachside face of the berm we had reinforced with cement-lined sandbags in November 2025 (Fig. 1). This design was approved by the Ephoreia after we requested it (Γ. Νίνος, Εργασίες ενίσχυσης του δυτικού αναχώματος για την προστασία της περίφραξης, Νοεμβρίου 2025).

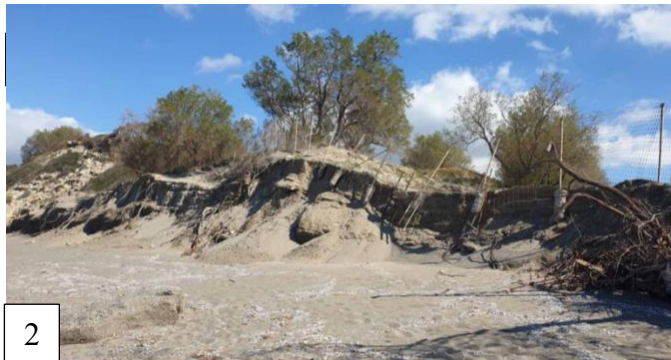
2

Over 60m of fence was undermined (Figs. 2-3). At the south the platform where cars park and where a bench and umbrella provide a resting place to

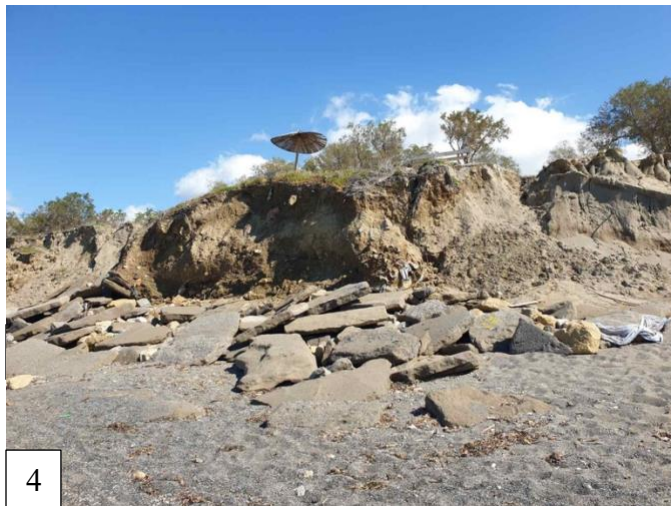
4

view the beach, has been eroded and the sloping access to the beach no longer is accessible (Figs. 4-5)

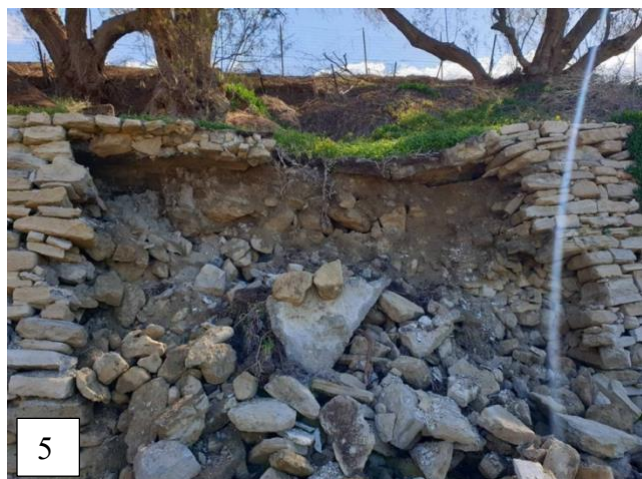
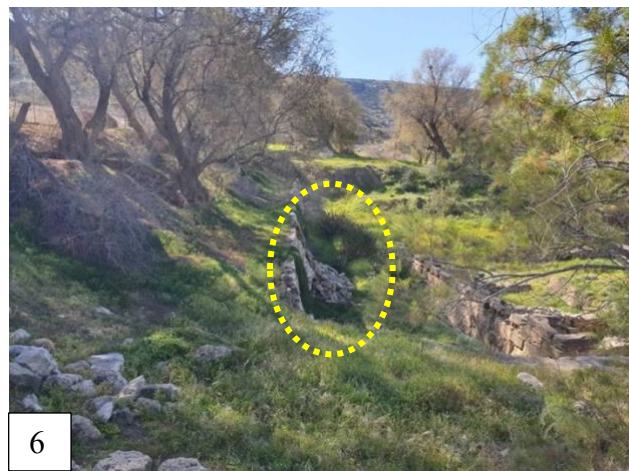
At the eastern side of the Kommos site the great terrace wall that since its construction in the early 1990s was breached (Figs.5-6). As a result the integrity of the entire terrace and the overlying sand and roadway behind and above it are now threatened.

and threaten especially the harbor installations and sanctuary remains of the Late Bronze Age through Roman times (Fig 6. Area in red in diagram).

The consequences of this damage are enormous. The destruction of the berm and fence means that the Kommos site is no longer secure: anyone can enter the site at any time. From a hydrological perspective, however, the consequences are dire. Further storms of this magnitude will collapse the road and the terraces

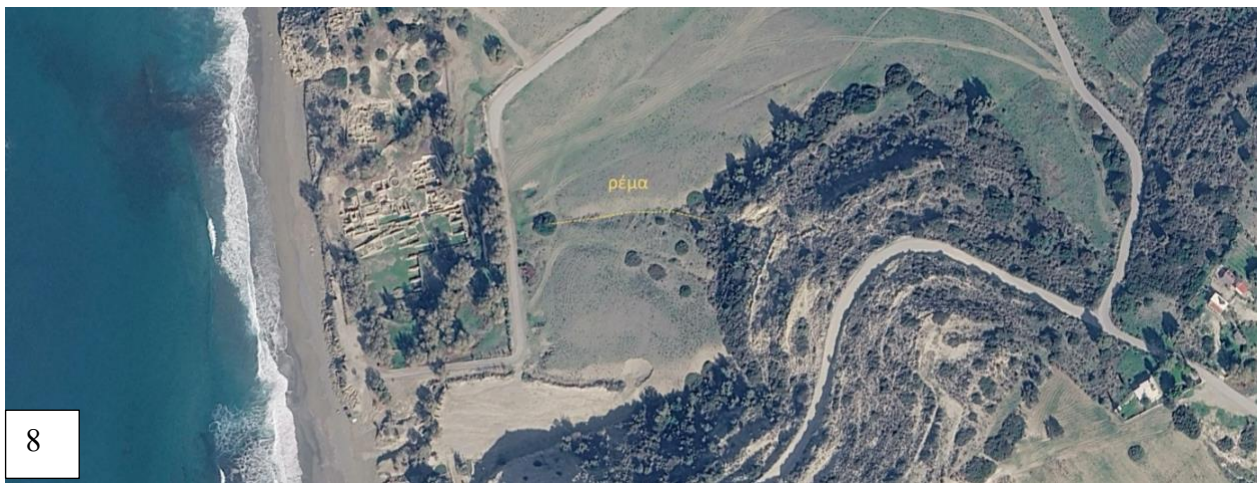
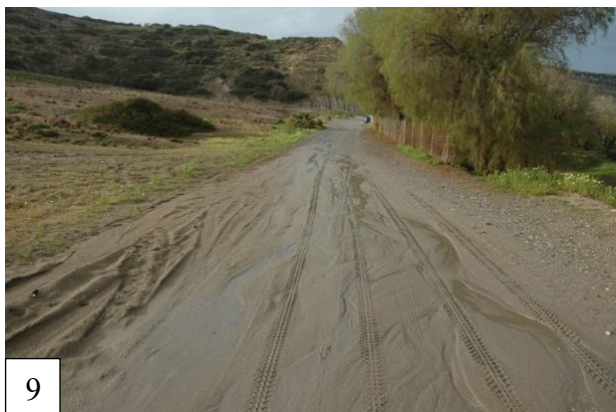
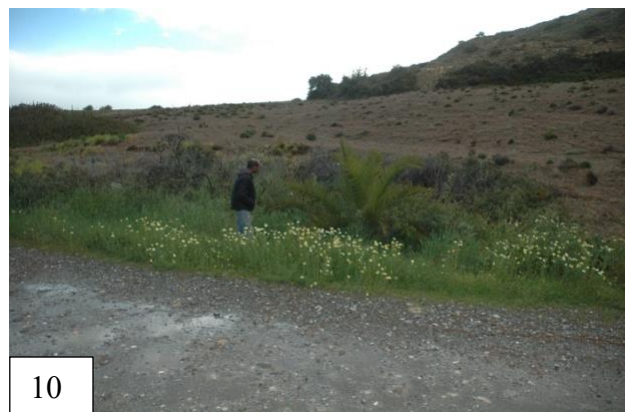
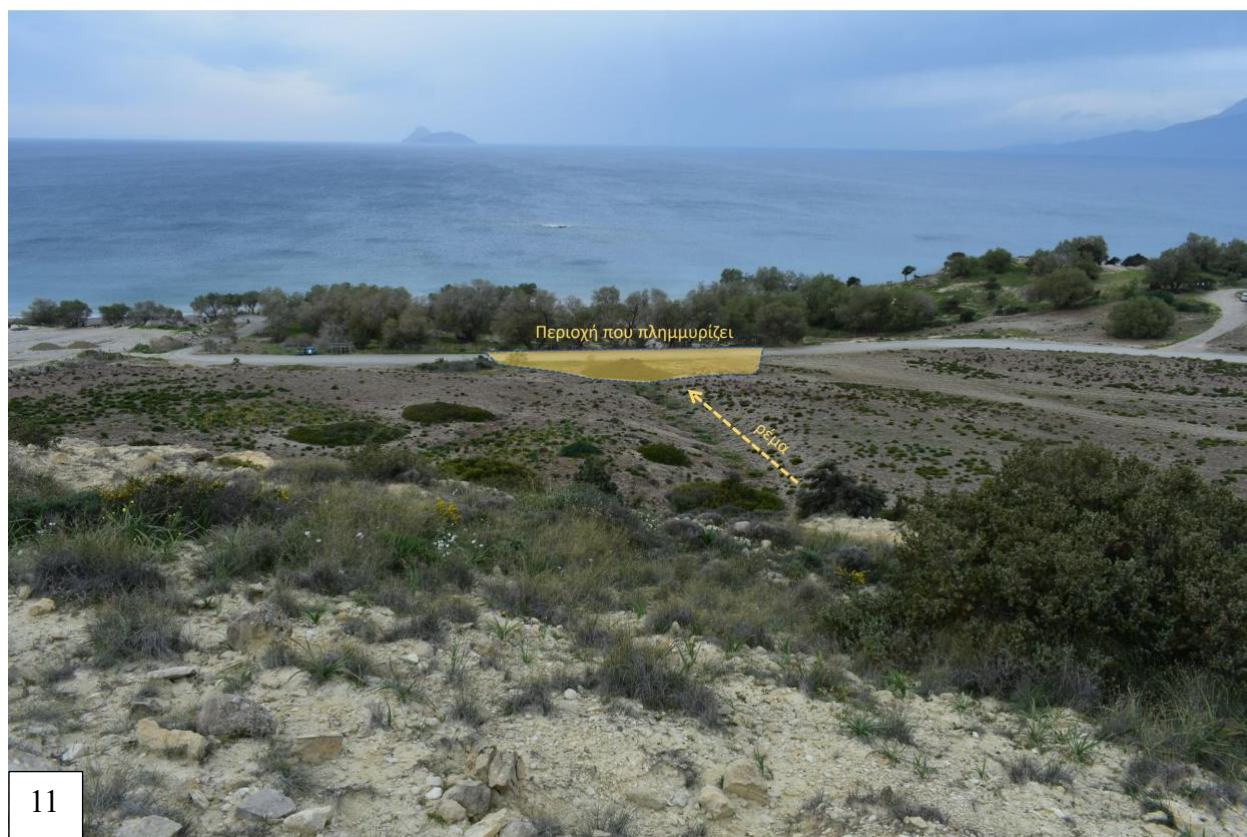
Where the road to the beach passes from North to South through the western area of  $\Lambda E$  as shown in the aerial map Fig 8, water gathers in a pond, and vegetation grows there. The three photographs (Figs. 9-11) below show how this area has flooded since the storm in February. The diagram of Fig. 12 shows not only how the water ponds in this area but also then saturates beneath the sand such that it ultimately builds up enough pressure to collapse the great Terrace wall (Figs. 5-6) that protects the antiquities of the Great Harbor Building T of the Neopalatial port at Kommos.
